# Mechanical Test Report

Equipment under Test (EUT): **UPSI-IP-1 Series**  
2 samples

Document No.: **MEC+BIC-19001-PR01-M01b**  
This document replaced test report MEC+BIC-19001-PR01-M01a.

## EUT : UPSI-IP-1 Series

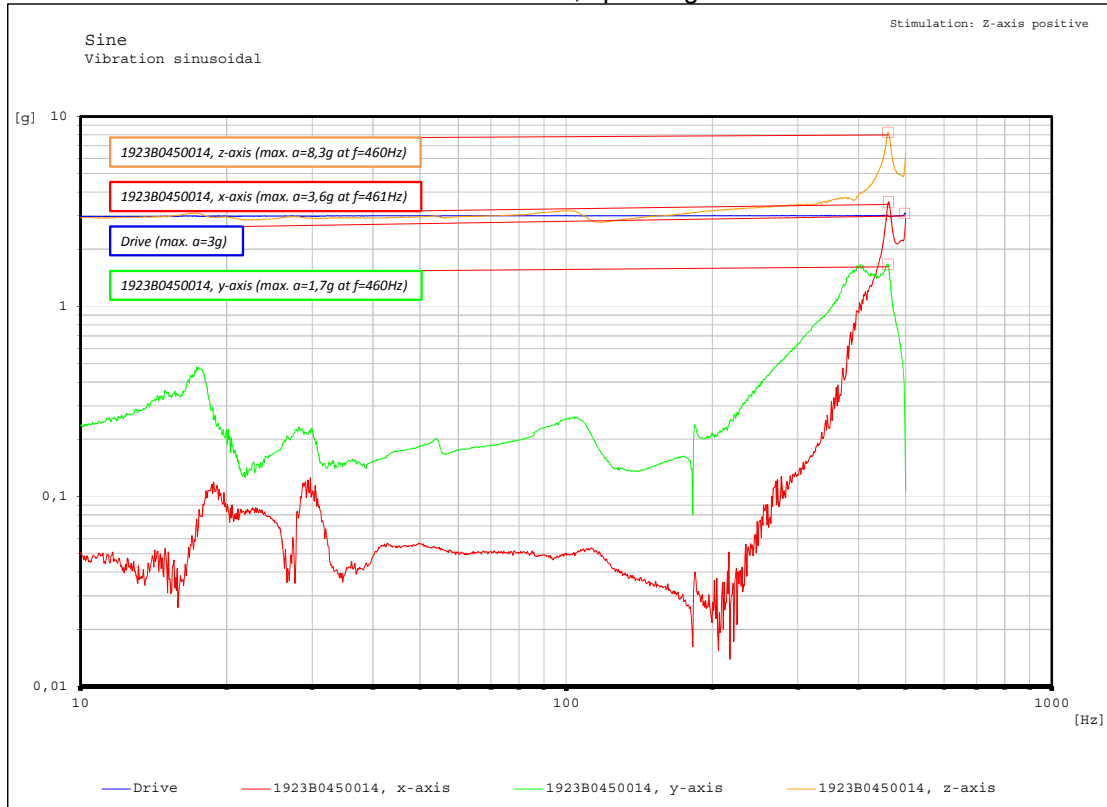
Fig. 5

Vibration sinusoidal, operating z-axis

| Test No. | Axis | Component | Test program | Test cycles | Results |
|---|---|---|---|---|---|
| 6 | z | 1923B0450014 | - | 22 sweep | passed, results according to fig. 5, page 12 |

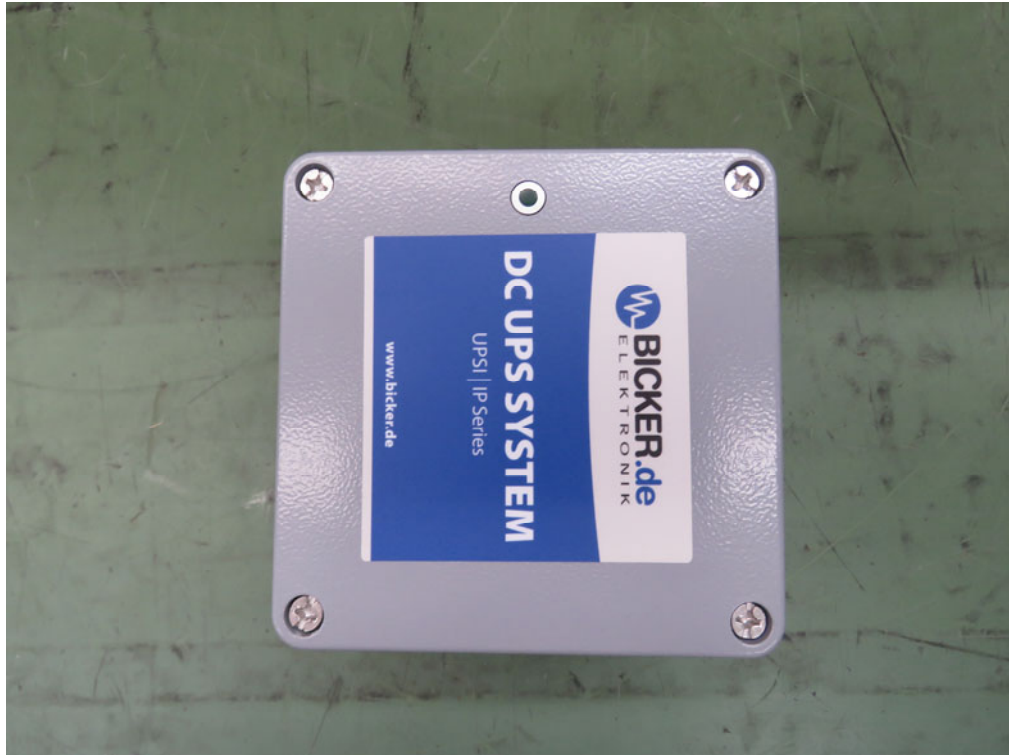
Picture no. 1: Top side of EUT

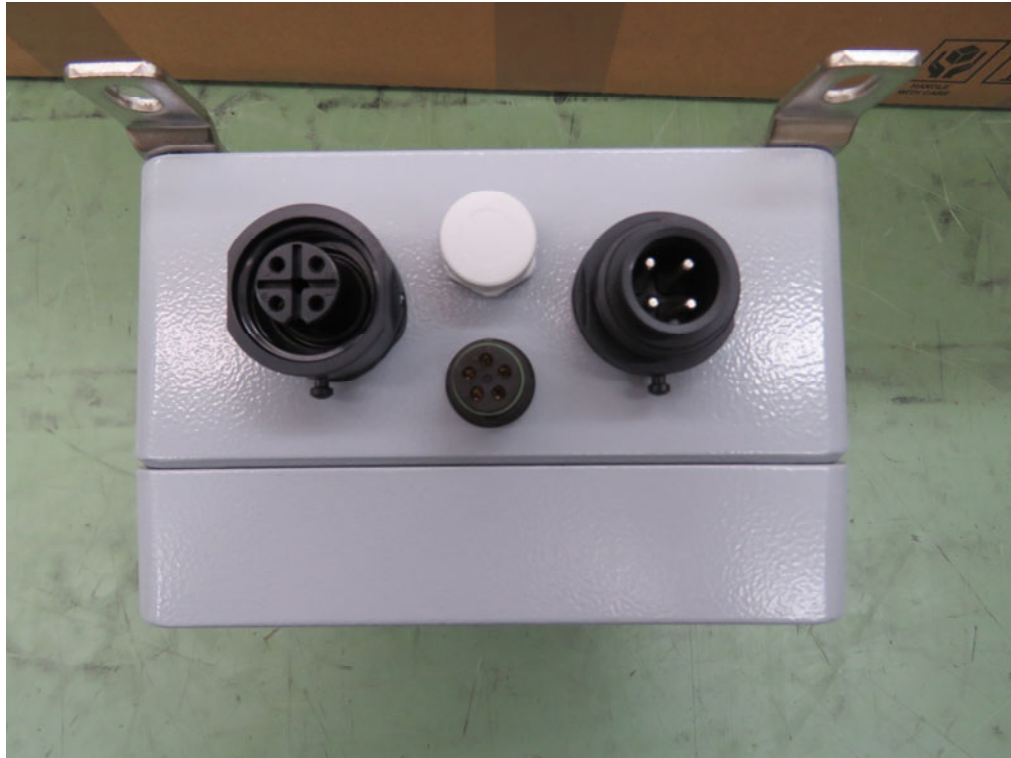
Picture no. 3: Connector side of EUT
